INDOOR AIR QUALITY ASSESSMENT

**Abigail Adams Intermediate School
89 Middle Street
E. Weymouth, Massachusetts**

Prepared by:
Massachusetts Department of Public Health
Bureau of Environmental Health Assessment
February, 2002

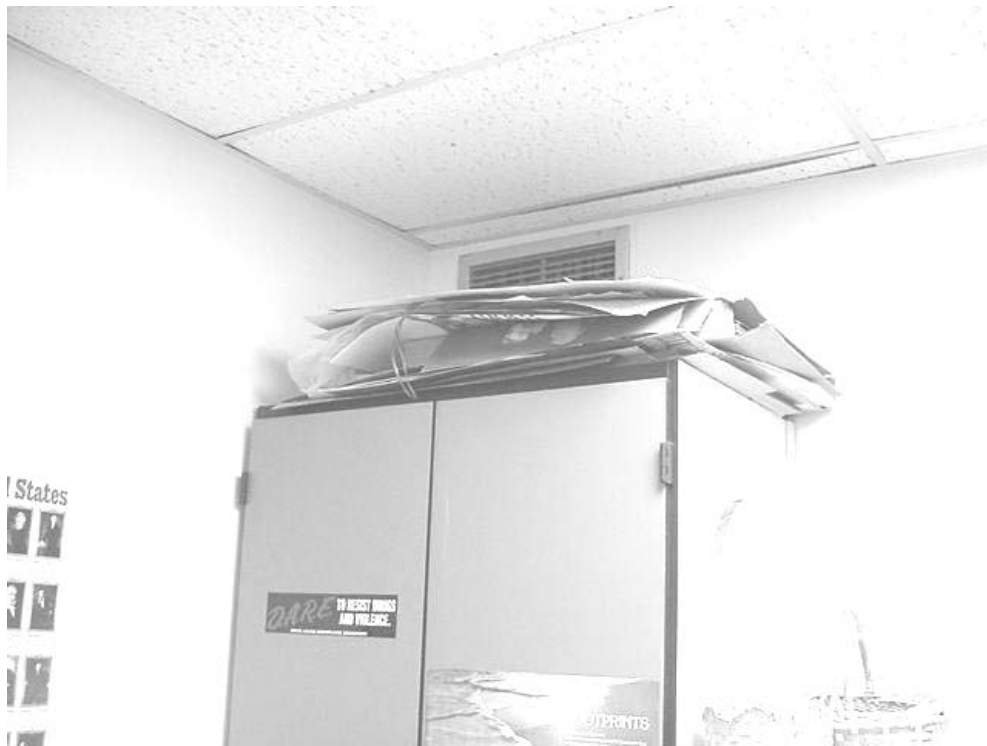
Picture 1

The mechanical exhaust ventilation system consists of wall-mounted exhaust vents or unit exhaust ventilators, which were operable in all areas surveyed. Wall-mounted exhaust vents in some classrooms are located approximately two to three feet above storage cabinets. Items were seen stored on top of these cabinets, blocking vents (see Picture 1). Care should be taken to avoid the blockage of these vents by items stored on top of these cabinets.

Partially Obstructed Exhaust Vent

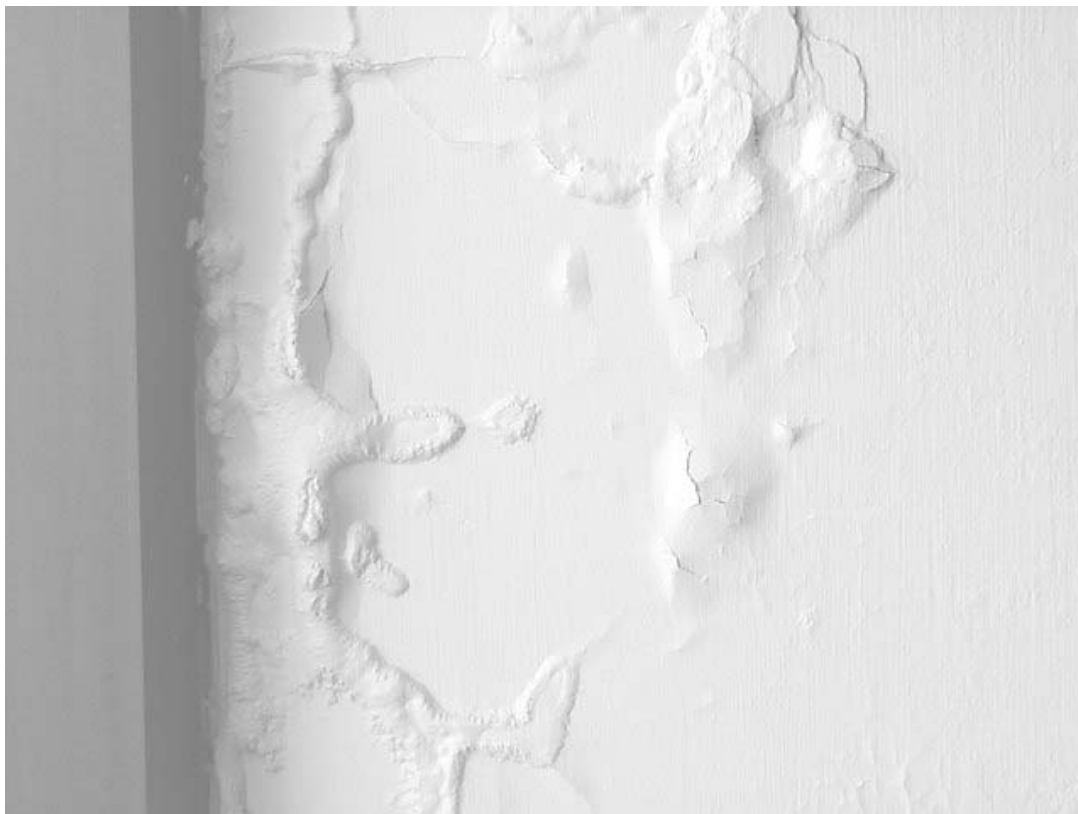
Picture 2

Exterior walls of the building show signs of water intrusion. Water penetration through window frames was evident by the presence of a heavy coating of efflorescence (e.g. mineral deposits) and water-damaged plaster (see Picture 2). Efflorescence is a characteristic sign of water damage to building materials such as brick or plaster, but it is not mold growth. As moisture penetrates and works its way through mortar around brick, water-soluble compounds in bricks and mortar dissolve, creating a solution. As the solution moves to the surface of the brick or mortar, water evaporates, leaving behind white, powdery mineral deposits. According to school maintenance personnel, rainwater penetrates into the interior walls through flashing around window frames. Without proper flashing, water can readily penetrate through window frames. Reportedly the WSD is appropriating funding for window replacement.

Water Damage/Efflorescence around Window Frame

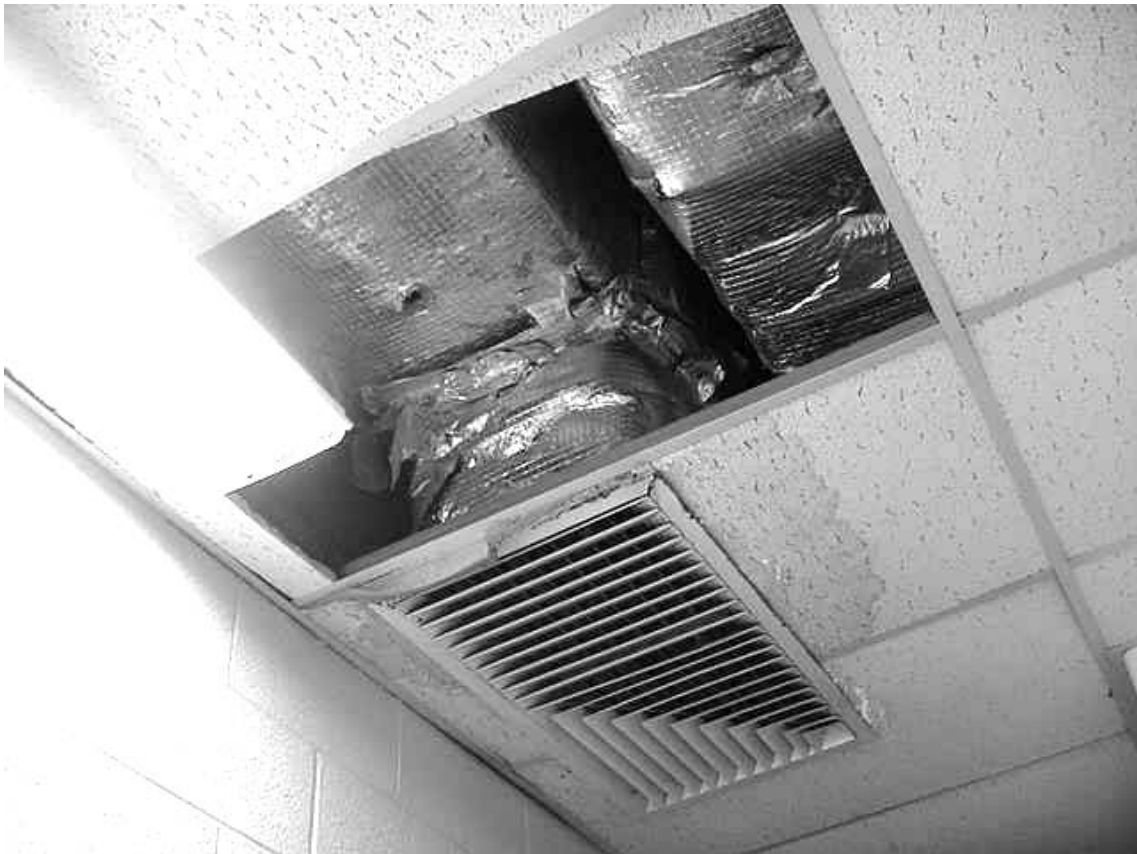
Picture 3

Some classrooms had water-stained and/or missing ceiling tiles (see Picture 3), which is evidence of historic roof or plumbing leaks. Water-damaged ceiling tiles can provide a source of mold and mildew and should be replaced after a water leak is discovered. In addition, missing ceiling tiles can provide a pathway for the movement of odors, fumes, dusts and vapors into occupied areas.

Water Stained/Missing Ceiling Tiles

6. Replace any remaining water-stained ceiling tiles. Examine the area above these tiles for mold growth. Disinfect areas of water leaks with an appropriate antimicrobial.
7. Consider relocating/reducing the amount of materials stored in classrooms to allow for more thorough cleaning. Clean items regularly with a wet cloth or sponge to prevent excessive dust build-up.
8. Replace missing and/or broken ceiling tiles to prevent egress of dirt, dust and particulate matter into occupied areas.
